Manhole Inspection Summary

Manhole # S21K__045MH

Insp Date: **9/25/07 11:20 AM**

Location Address: **233 FULTON-BRUCE**

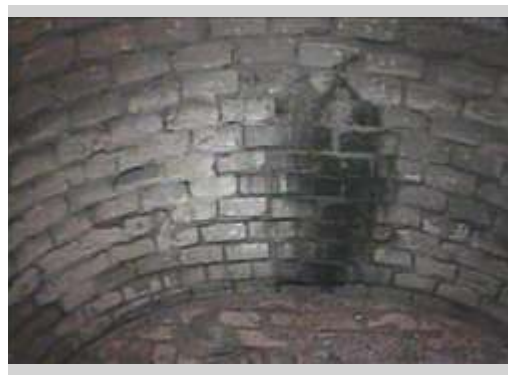
Defect 4

Infiltration: ☐ None ☐ Joint ☐ Cracks ☐ Mortar ☐ Roots ☒ **Wall**

BARREL INFILTRATION

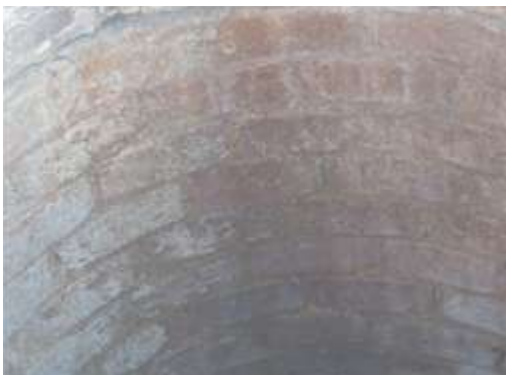
Defect 3

Infiltration: ☐ None ☐ Joint ☐ Cracks ☐ Mortar ☐ Roots ☒ **Wall**

CORBEL INFILTRATION

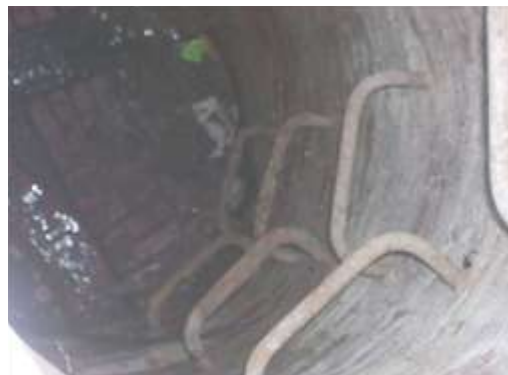
Defect 2

Count: **8** Missing: **0** ☒ **Corroded**

CORRODED STEPS

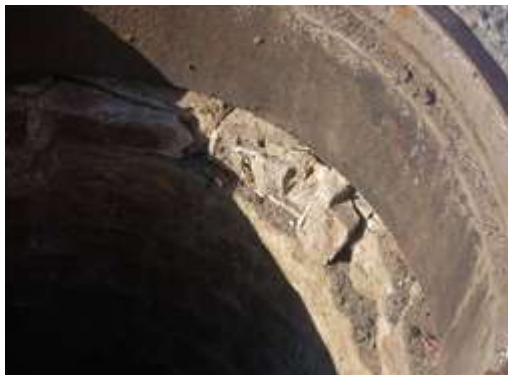
Defect 5

Condition: ☐ Sound ☐ Cracked ☐ Root Intrusion ☐ Loose Brick ☒ **Deteriorated**

DETERIORATION OF CHIMNEY

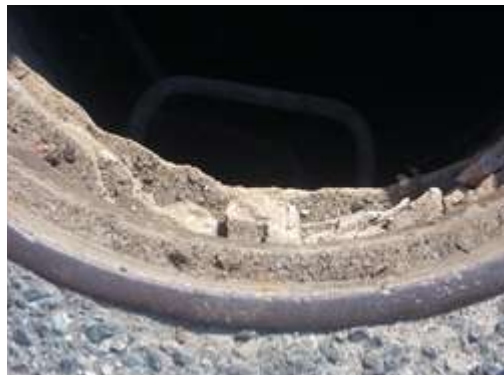
Defect 1

Offset: **1** (in.)

FRAME OFFSET

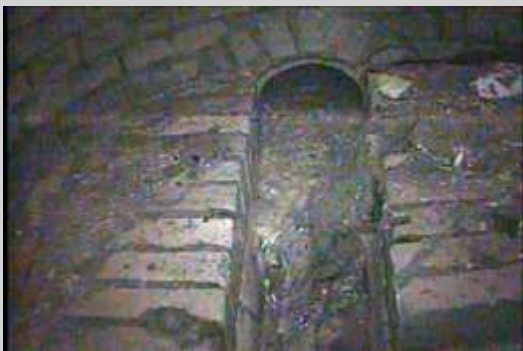
6 O'Clock Inflow

Pipe Height: **8.4** (in.) Rod and Bar (Angled)
Pipe Material: **Clay** ☐ Pipe Lined
Invert Depth: **13.92** (ft.) Flow Characteristics: **Slow**
Deposits: ☐ None ☐ Mud ☒ **Sludge** ☐ Debris ☐ Grease
Silt Depth: **5** (in.) Deposits Extent: **Medium**
Infiltration: **None** Pipe Seal Cond: **Sound**

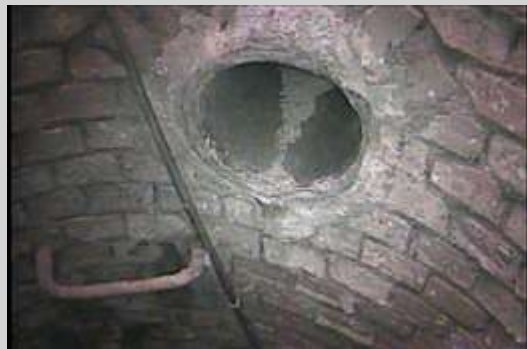
CORRODED STEPS
